Township of Havelock-Belmont-Methuen Regular Council Meeting Agenda

Building Envelope Condition Assessment (BECA) Report

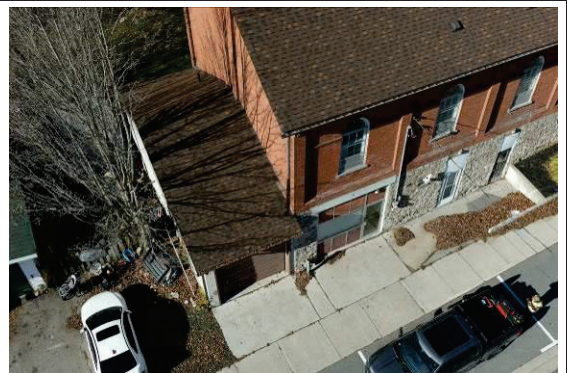
Description:
General view of the slope metal roof on the North Front Entry.

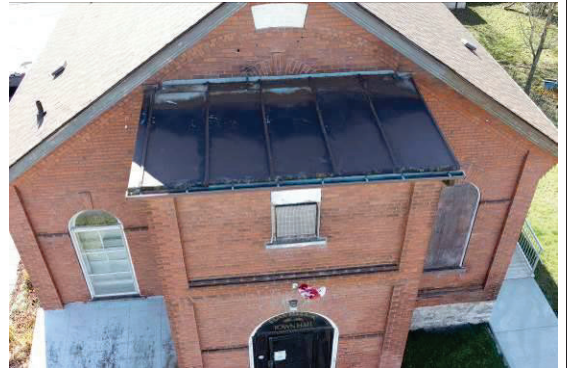
Description:
Closeup view of corroded standing seam metal roof panels.

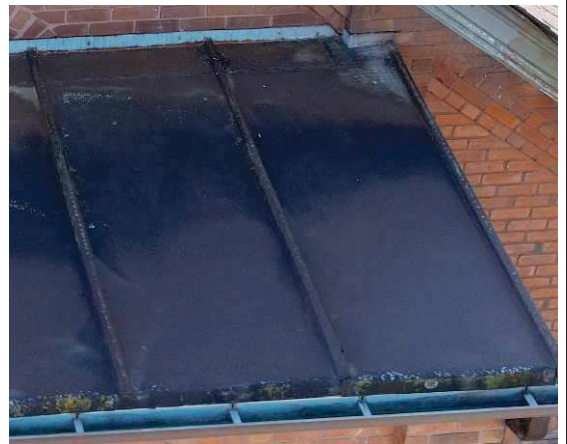
Description:
General view of the slope metal roof on the North Front Entry.

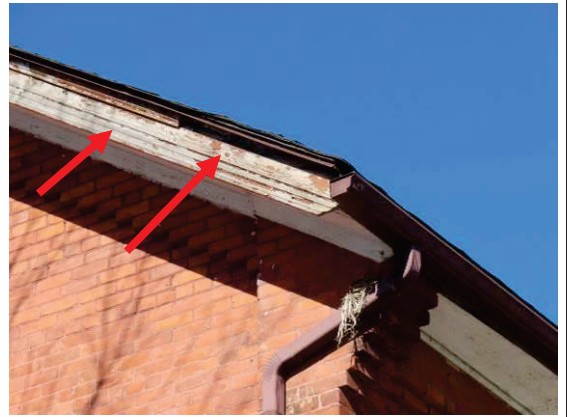
View of missing wooden fascia board.

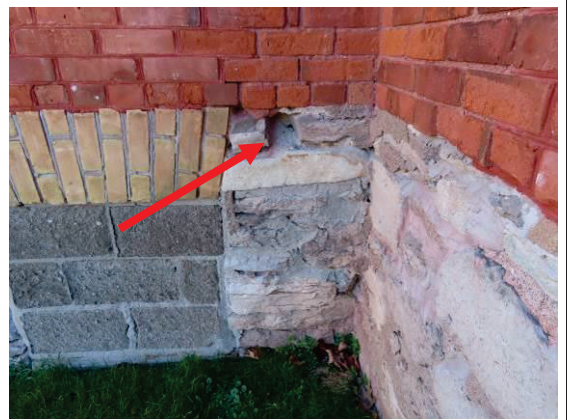
Description:
Vertical crack on the stone foundation wall. Additionally, the general condition of the mortar between stone units were found to be in poor condition.

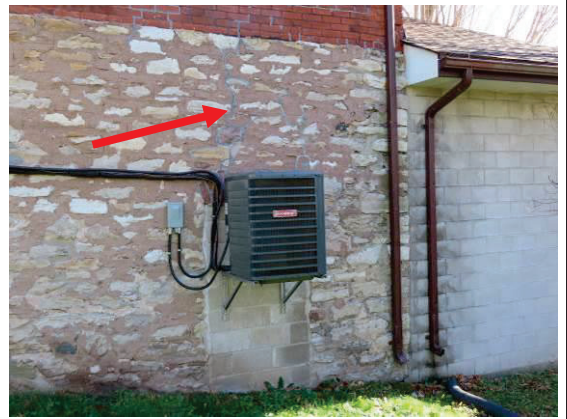
Description:
View of typical poor condition of stone foundation wall at grade level.

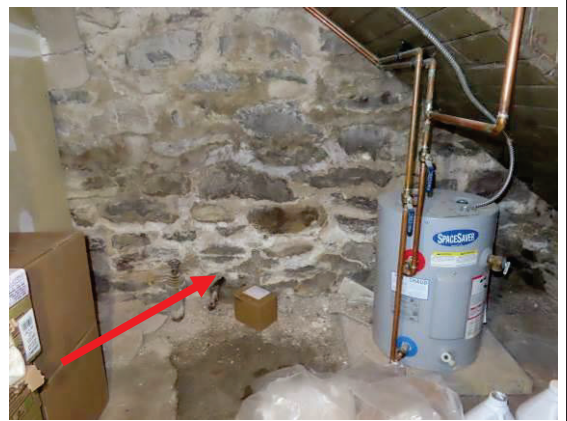
View of damaged plaster finish at the bottom of the interior side of foundation walls within the lower level basement. Damage appeared to be the result of leaks from stone foundation walls.

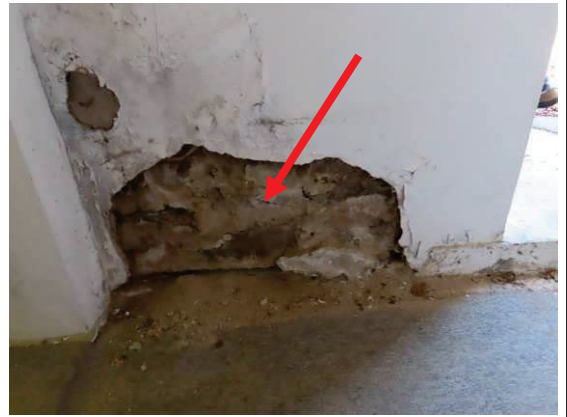
View of typical poor and failed mortar between masonry brick units at the bottom of a typical exterior window.

Note that poorly applied caulking has been incorrectly applied to failed mortar of masonry brick wall.

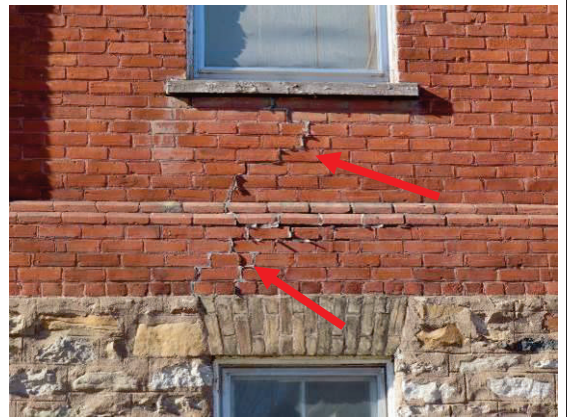
Closeup view of severely deteriorated and missing mortar between masonry brick units at an outside exterior wall corner. This defect is suspected to be the result of water leakage from a past leaking roof eavestrough and/or downpipe at this location.

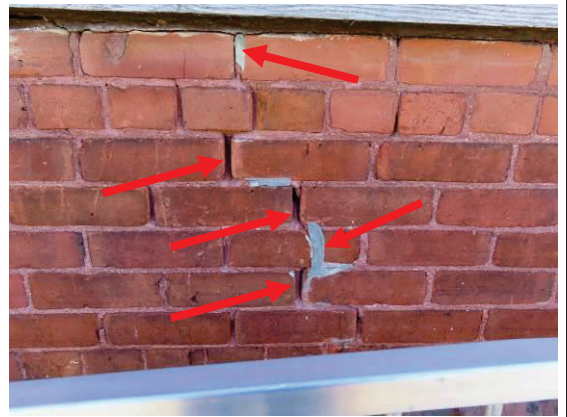
Description:
View of severely deteriorated outside wall corner with failed mortar joints.

Note that poorly applied caulking has been incorrectly applied to failed mortar of masonry brick wall.

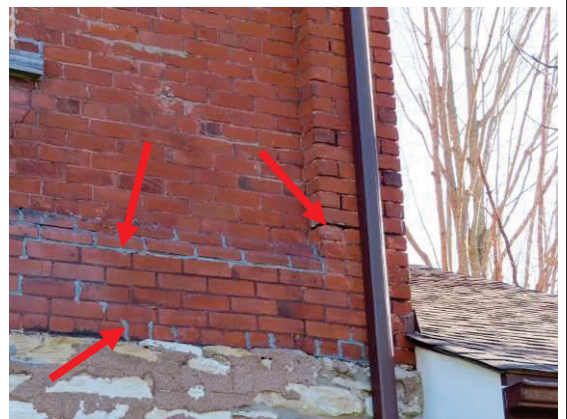
Description:
Damaged bricks and failed mortar were observed at the tops of all masonry arch lintels above the exterior windows.

Note that poorly applied caulking has been incorrectly applied to failed mortar of masonry brick wall.

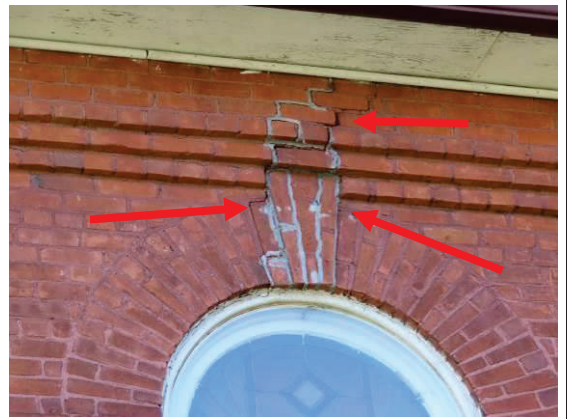
Description:
View of a poor repair performed at the masonry wall above the exterior window.

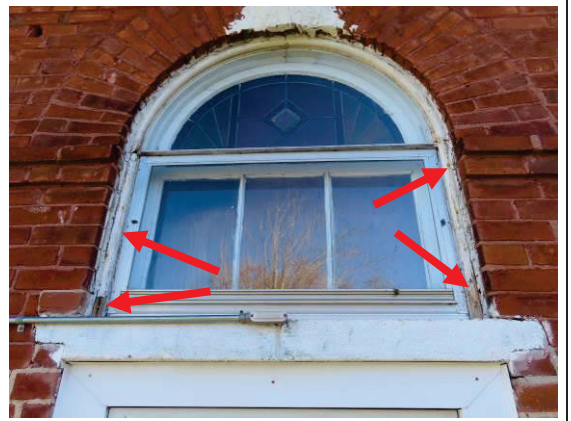
Description:
Rotted and damaged window frame.

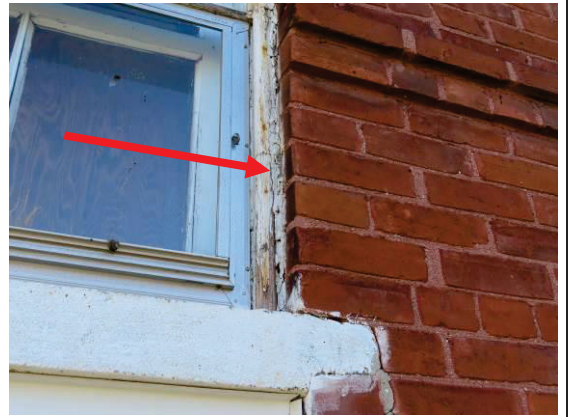
Typical view of severely deteriorated sealant around exterior windows and door.

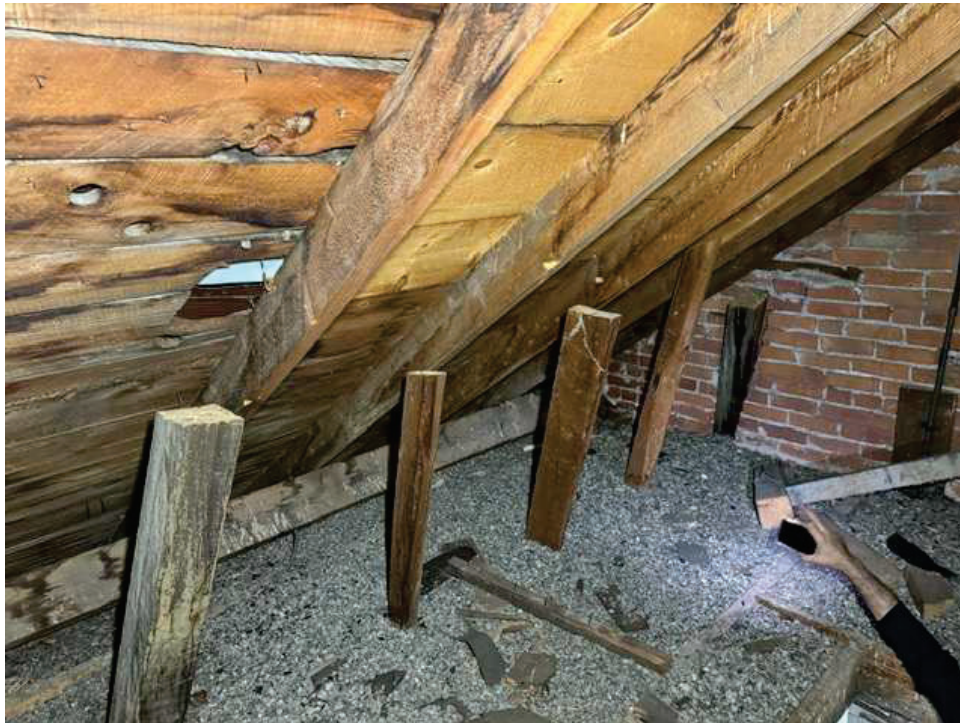
Photo #5

General View of the Attic Looking South – Scattered Debris, Deteriorated Materials, and Aged Rafters with Inadequate Bracing

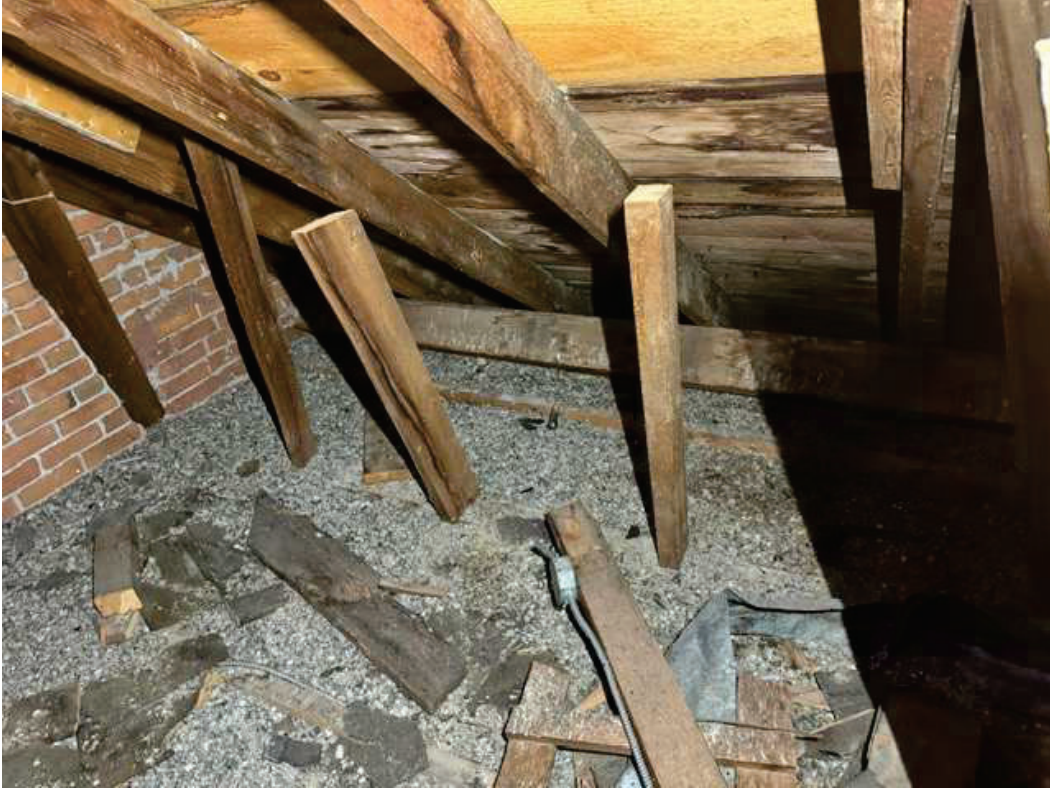
Photo #6

Northwest Attic Corner Looking Northwest – Deteriorating Wooden Rafters with Visible Damage, Including Missing Sections, Signs of Decay, and Inadequate Load Transfer Mechanisms

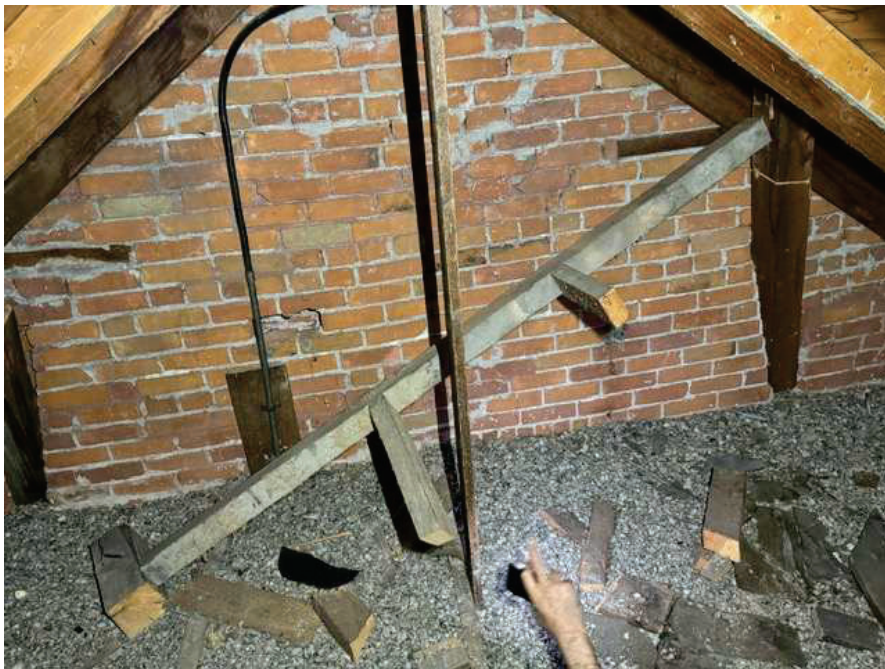
Photo #7

Northeast Attic Corner Looking Northeast – Deteriorating Wooden Rafters with Visible Damage, Including Missing Sections, Signs of Decay, and Inadequate Load Transfer Mechanisms

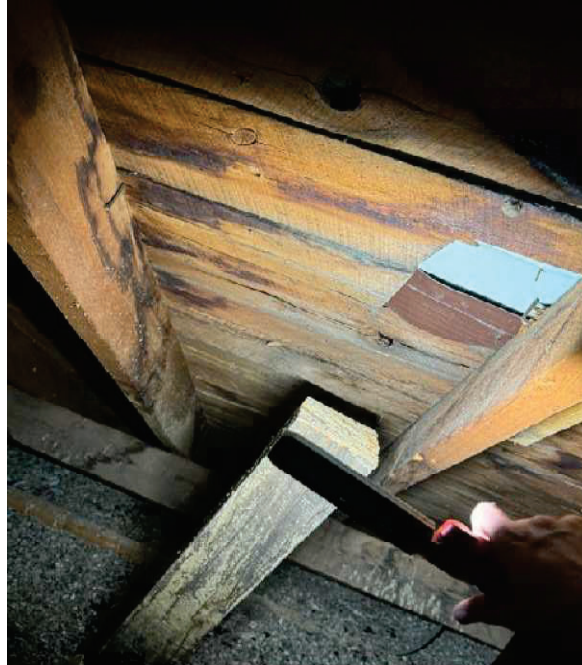
Photo #8

North Side Wall in the Attic Looking North – Irregular Bracing, Deteriorated Wood, Cavities in the Brick Wall, and Irregular Anchoring Requiring Further Detailed Assessment

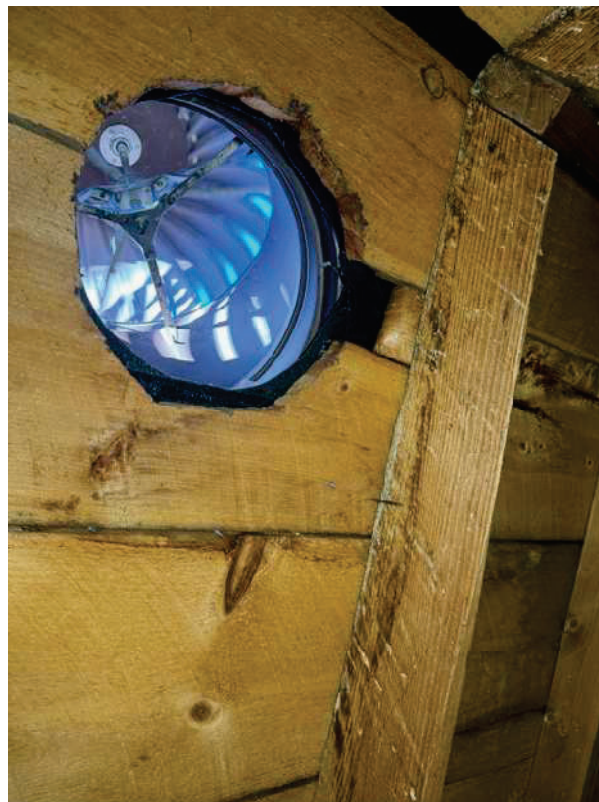
Photo #9

Close View of Ventilation Opening – Deteriorated Wood, Cut Bracing, and Cavities in Roof Boards.

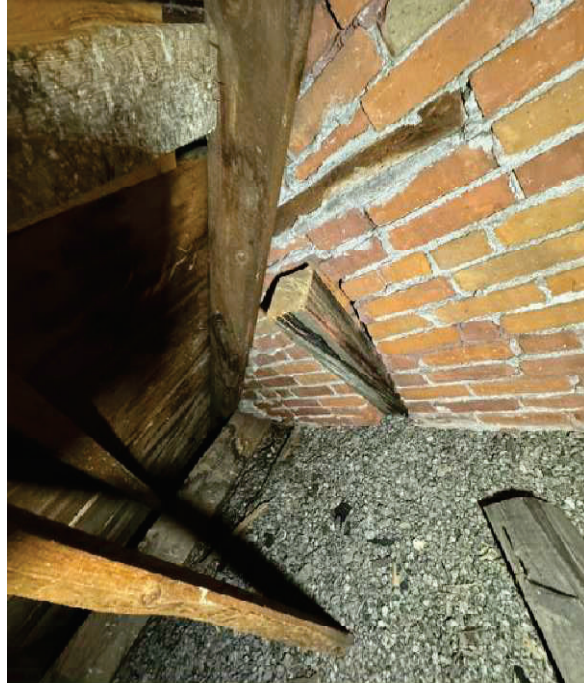
Photo #10

Close view at other a poorly executed ventilation opening with uneven cuts, indicating potential for moisture ingress and further structural concerns.

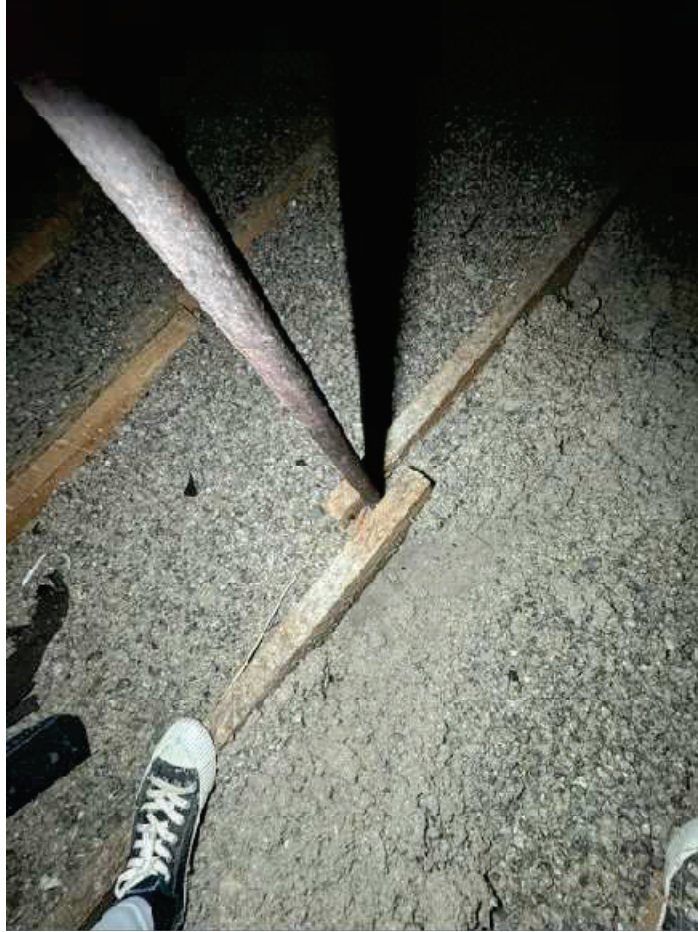
Photo #12

Close View of Roof Structure – Deteriorated Wooden Rafters and Bracing, with Roofing Boards of Varying Sizes and Conditions Indicating Past Renovations.

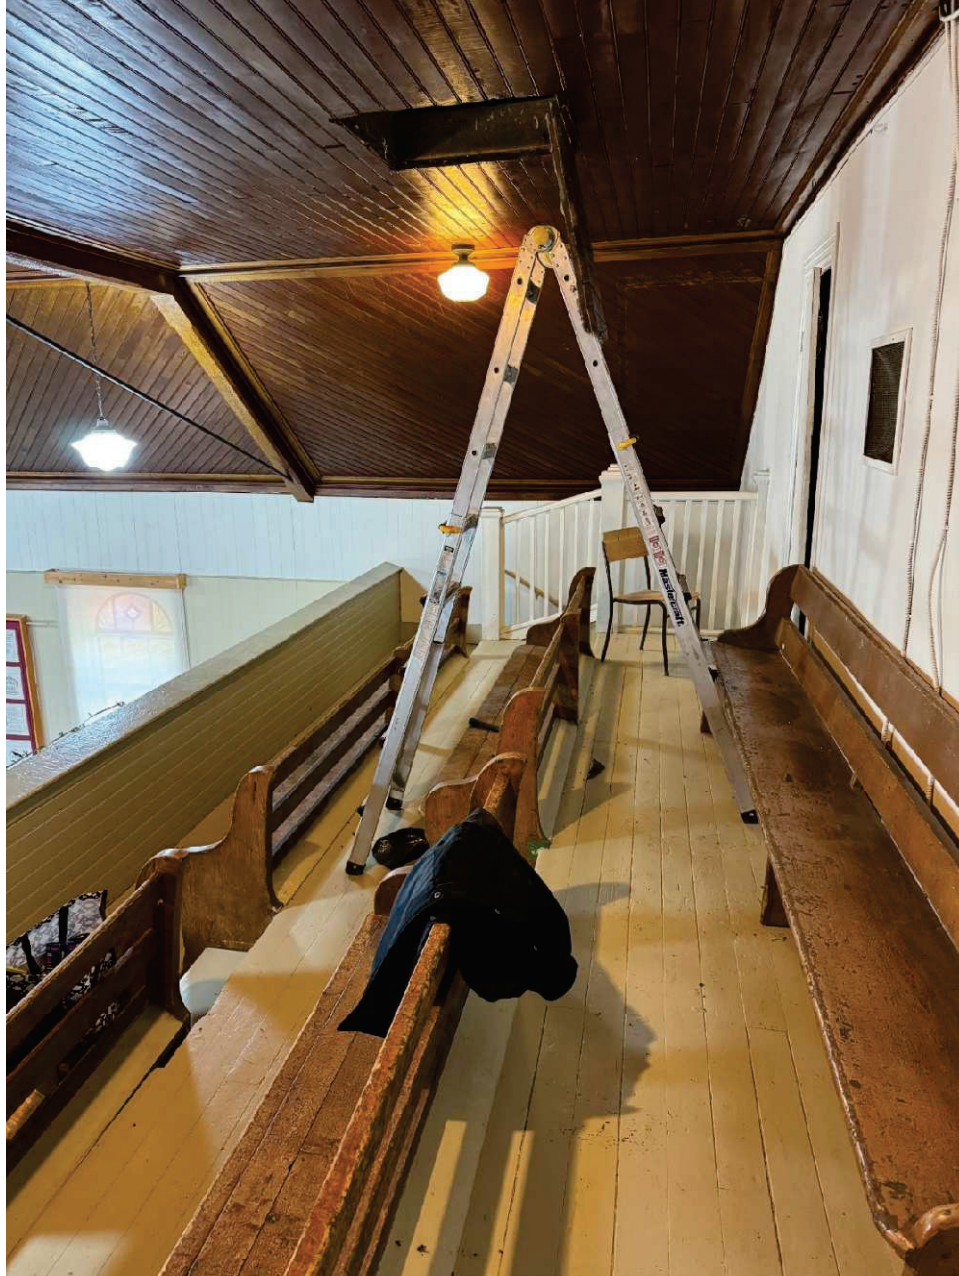
Photo #17

View of Bleacher/Viewing Balcony on Mezzanine Level – No Signs of Distress, Deflection, or Misalignments Observed in Walls, Floor, or Over Door to Mechanical Room. Attic Access Opening Shown in Ceiling Overhead with Ladder Used for Attic Entry, Looking East.

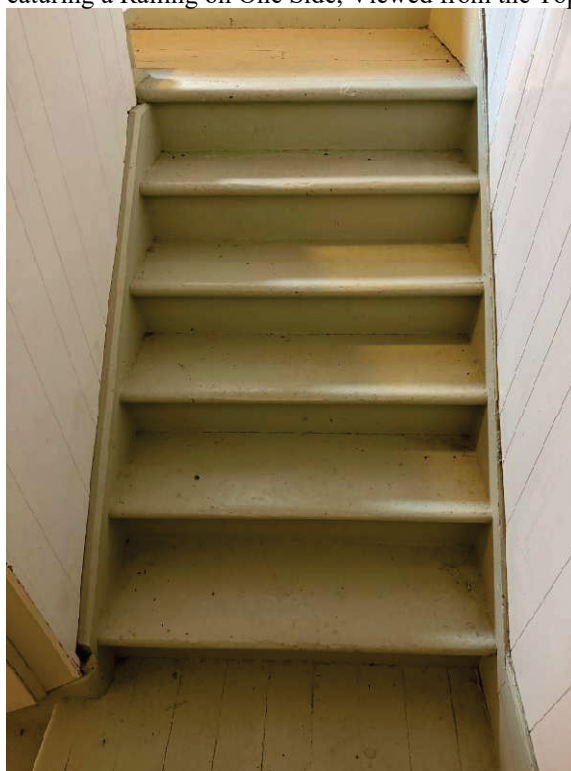
Photo #23

Wooden Staircase from Bleacher to Landing –
Featuring a Railing on One Side, Viewed from the Top.

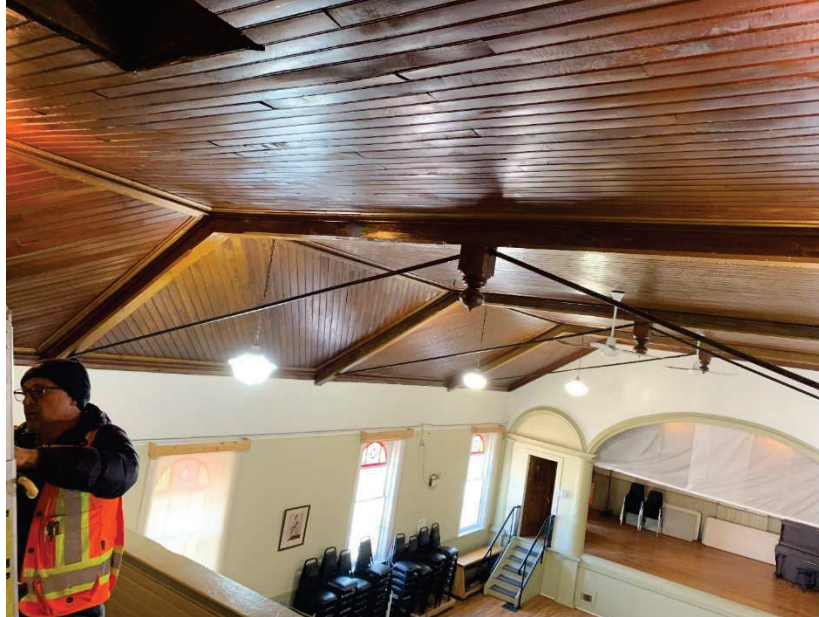
Photo #25

View of the Town Hall from Bleacher – Featuring a Wooden Vaulted Ceiling with Visible Wood Roof Trusses and Steel (~35mm Diameter) Tension Ties/Cables Connecting the Top of Supporting Brick Walls/Columns to the Truss Center. The Photo Also Shows the Performance Stage, Stairs to the Stage, and the Main Hall Below. Looking Southwest.

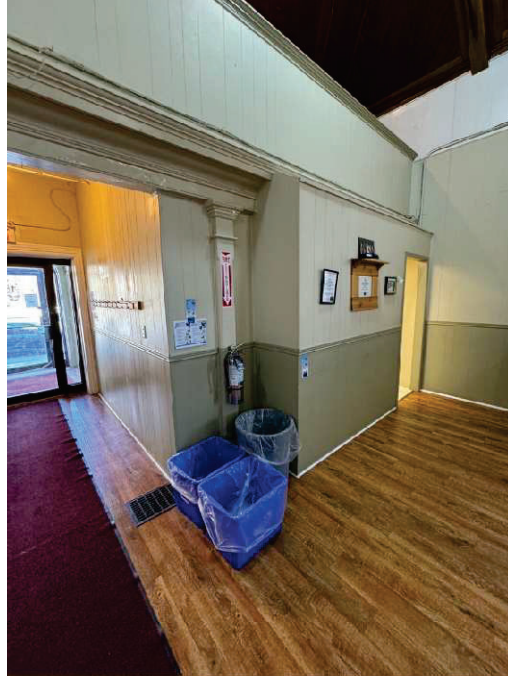
Photo #32

Corridor Leading to the Town/ Banquet Hall
View Looking North

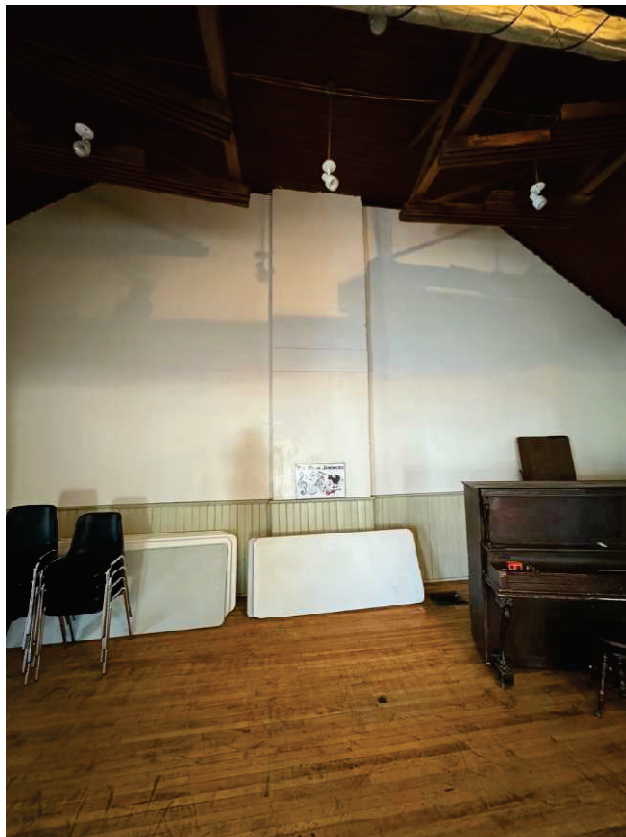
Photo #37

Stage Area, Looking East, Highlighting Structural Integrity of the Supporting Architectural Arch below the Roof Truss, Walls, and Roof with No Visible Signs of Distress, Misalignment, or Structural Defects

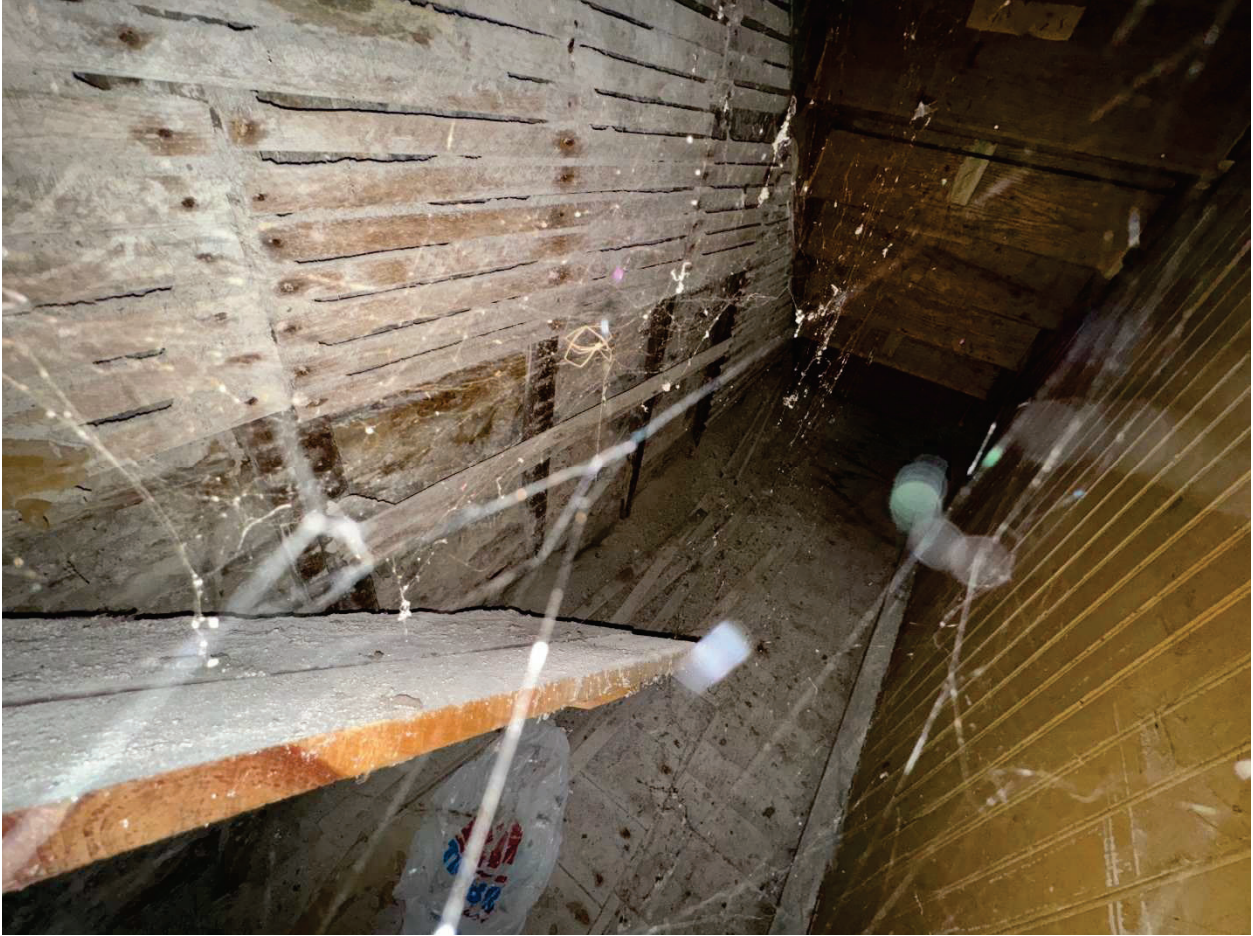
Photo #46

Storage Room Below North Basement Stairs at Northeast Corner, Looking North. Interior wall finishes are deteriorated, exposing the wooden lath beneath.

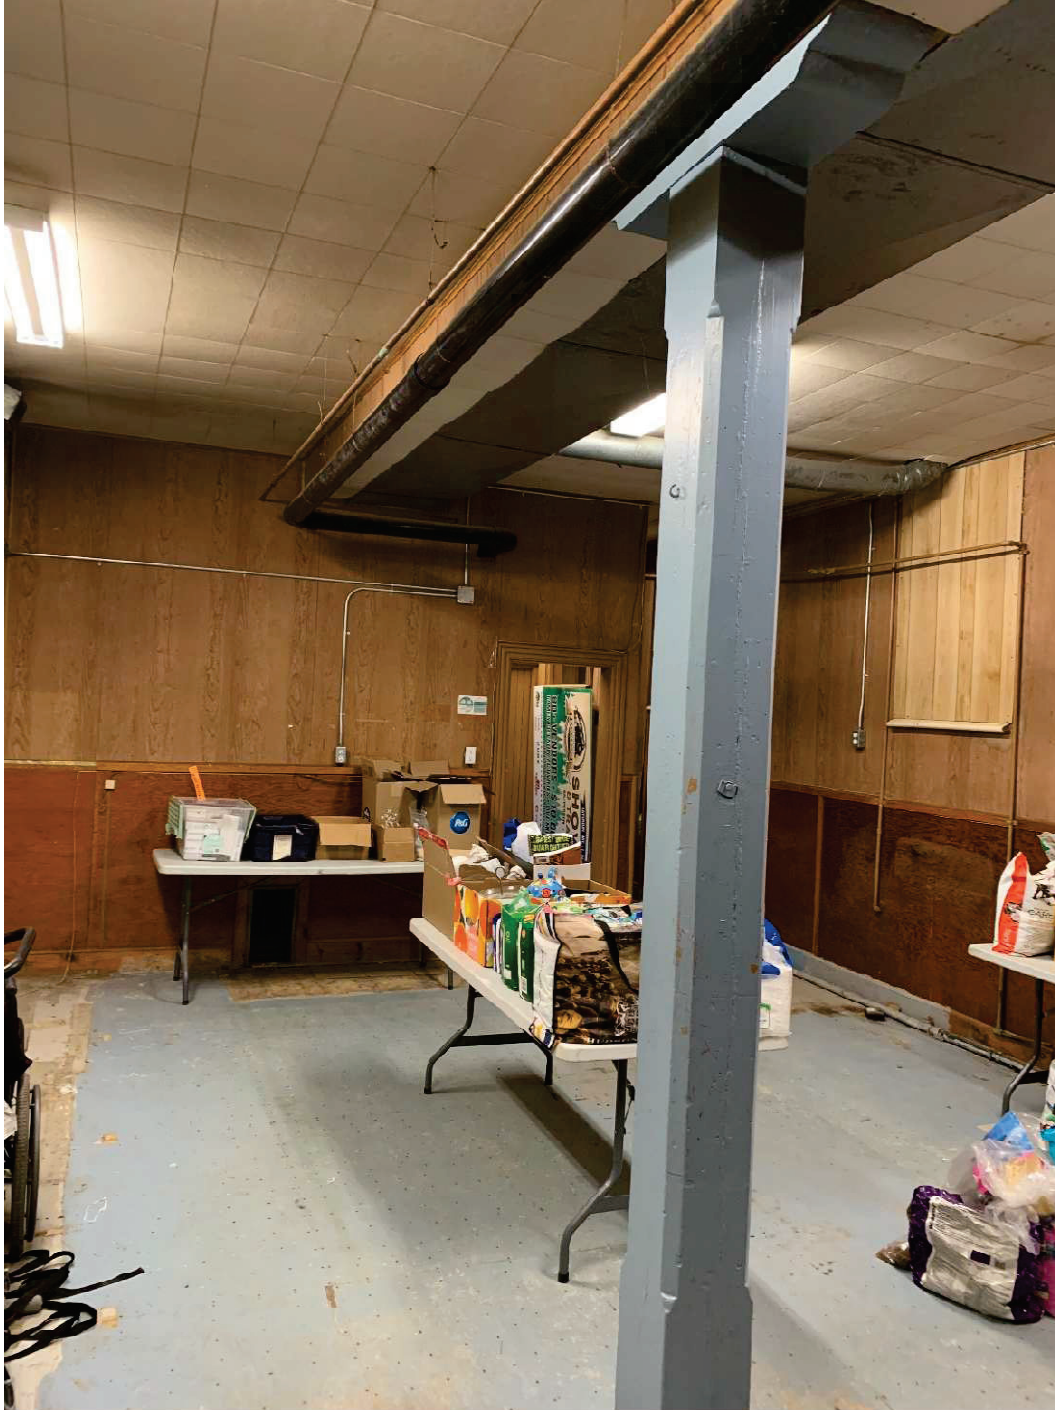
Photo #49
Basement east wall, looking west.

Photograph #49 shows the basement's east foundation wall from the inside, looking west.

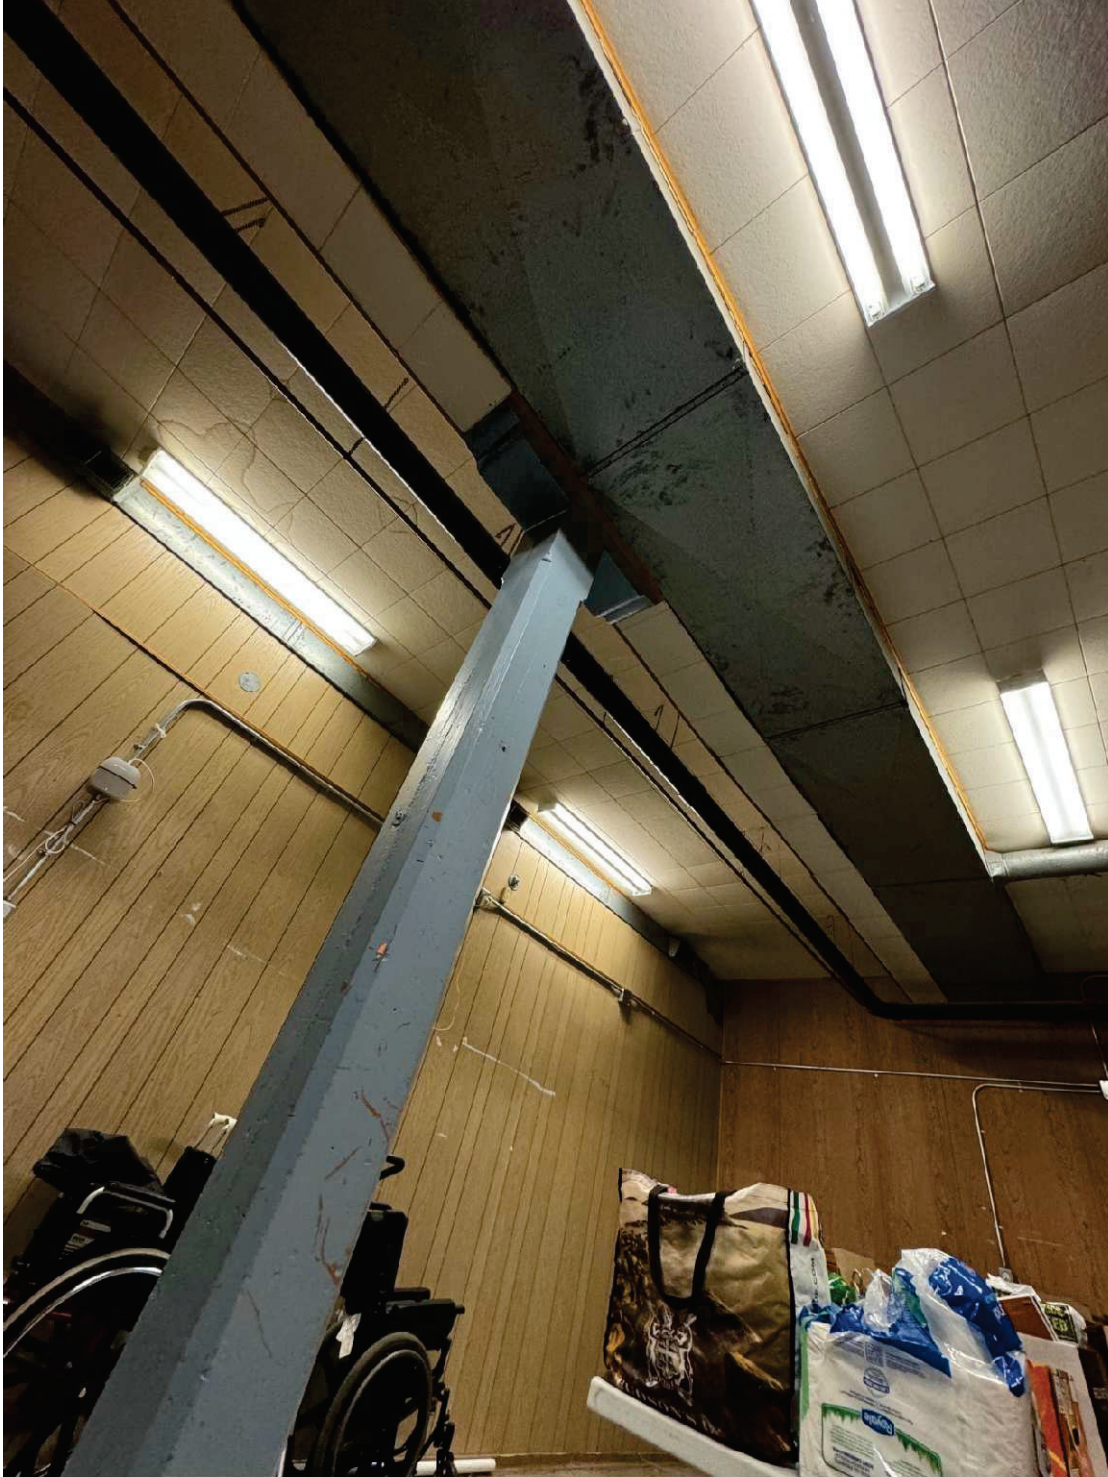
Photo #50

Photographs #50, & #51 show the food bank area in the basement, with a structural column and overhead beam, looking southwest: The column appears to be constructed of wood and is painted gray. It includes a capital-like detail at the top where it meets the overhead beam. The column shows no visible signs of damage, cracking, or instability. The overhead beam is hidden in the ceiling finishes and spans horizontally north- south and appears to be made either of steel or wood. It is well-integrated with the column and other structural elements, supporting the ground floor structure above. The ceiling consists of acoustic tiles, which display discoloration and staining in certain areas, possibly indicating previous water damage or leaks. A portion of the ceiling near the beam appears uneven or slightly sagging, warranting further inspection to ensure it is secure and supported properly.

Food bank area with a structural column with capital and overhead beam, looking southwest.

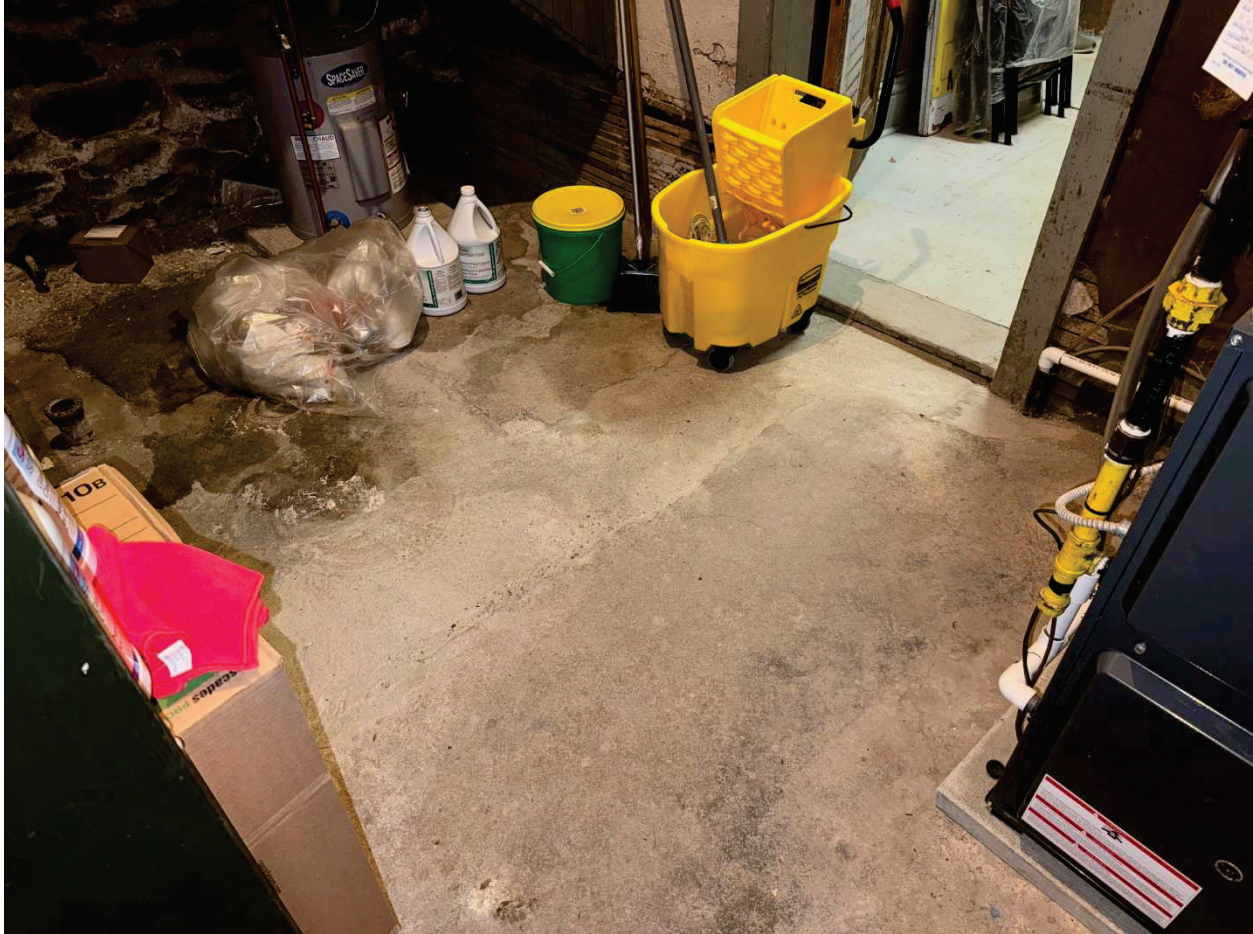
Photo #52

Photograph #52 shows the Mechanical Room (Looking West) where the overhead ductwork and equipment are properly supported. The concrete slab on grade appears to be in generally fair condition, with no visible signs of significant cracking, settlement, or heaving. Minor surface wear and staining is present, but it does not appear to compromise the slab's structural integrity.

Basement mechanical room, looking west. The south side features a new partition to the police office. The concrete slab on grade appears to be in generally fair condition, with no visible signs of significant cracking, settlement, or heaving

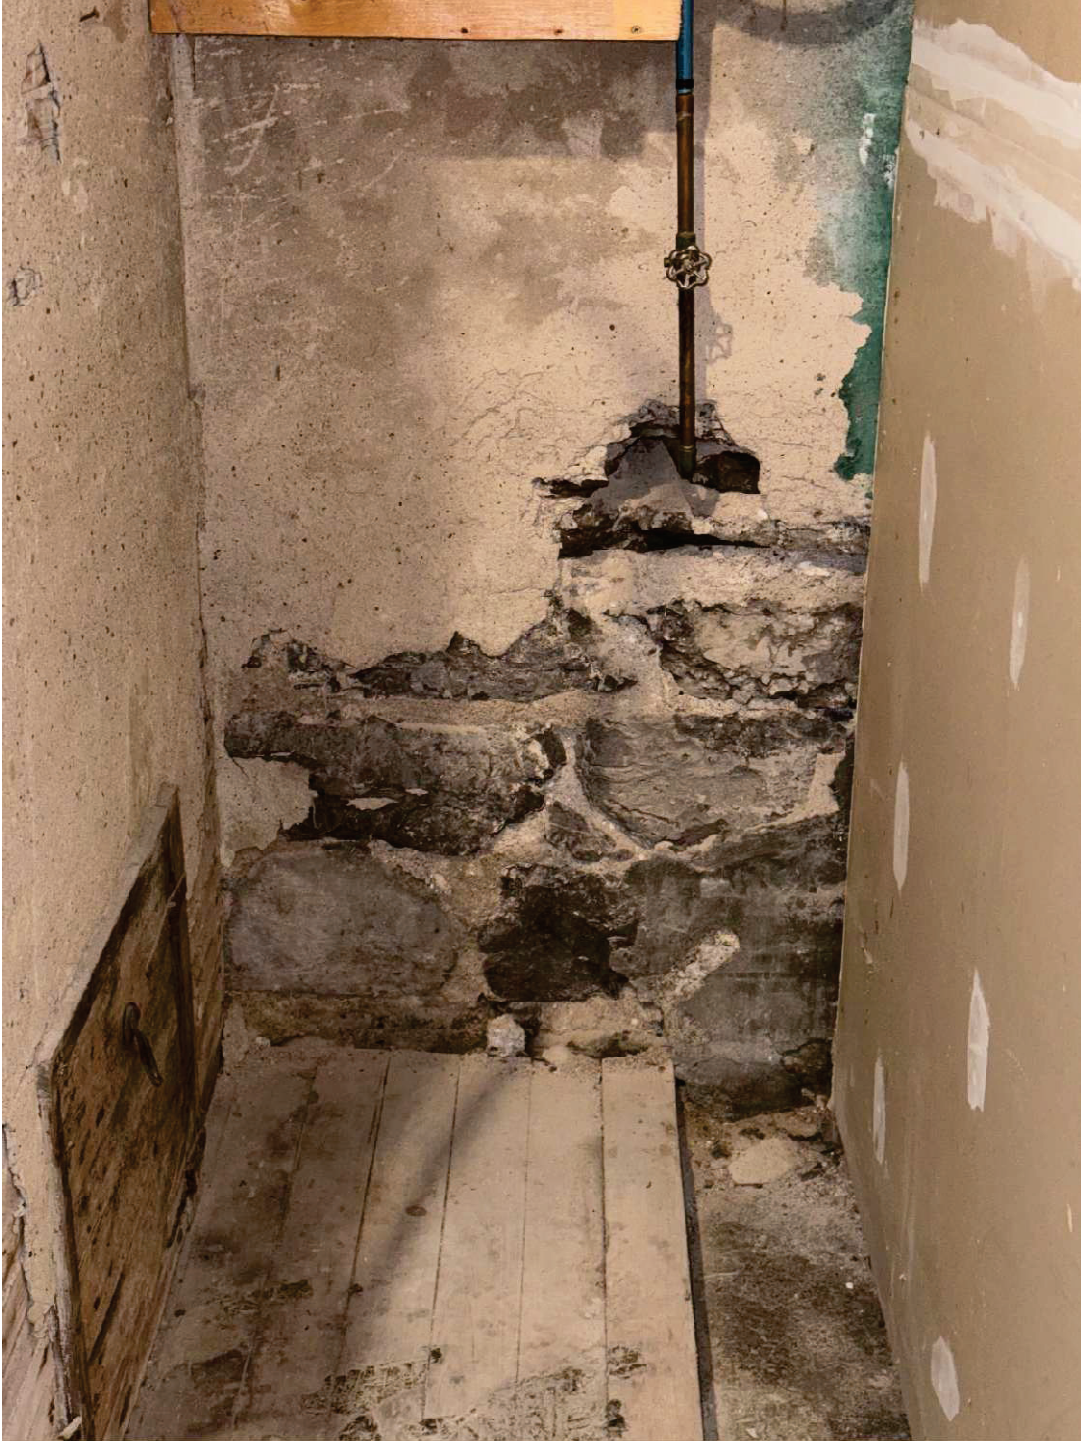
Photo #54

Closer view of the east foundation wall below the stairs, looking east. Local damage to the slab-on-grade has been observed and should be repaired promptly. The stone masonry foundation wall shows signs of mortar joint erosion and surface degradation, which may reduce its lateral support capacity and resistance to hydrostatic pressure. Repointing and sealing the joints are recommended to enhance stability and durability.

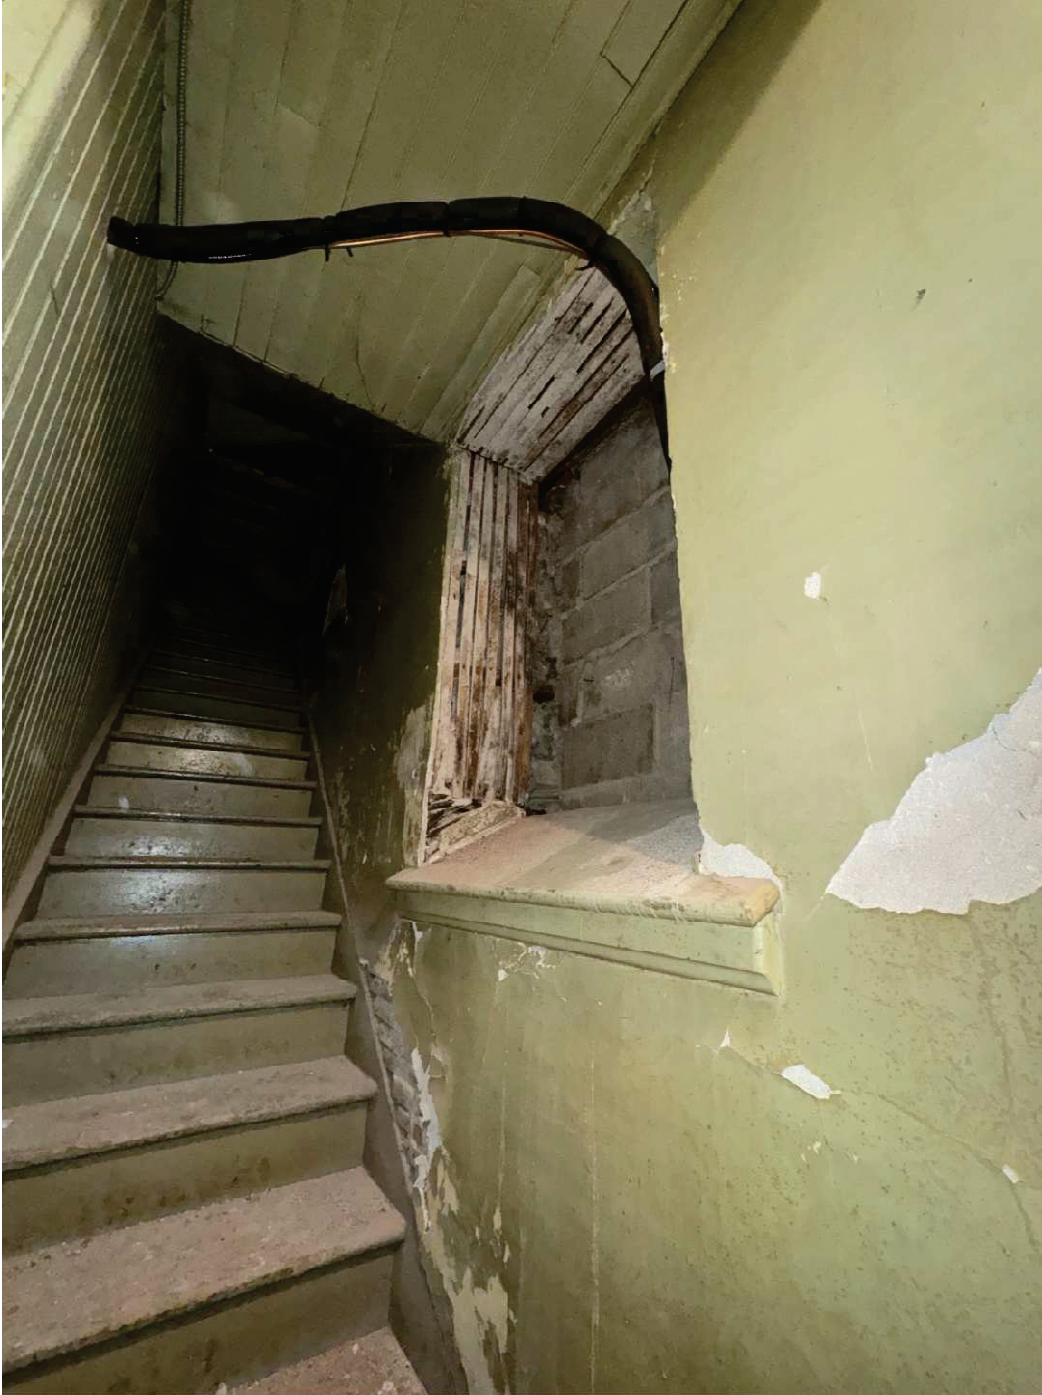
Wooden stairs leading to the stage area, closed off at the top during the inspection for an unknown reason. The stairs exhibit visible wear, including surface damage and discoloration.

The interior finishing of the east foundation stone masonry wall under the stairs shows some deterioration, with missing mortar and signs of spalling.

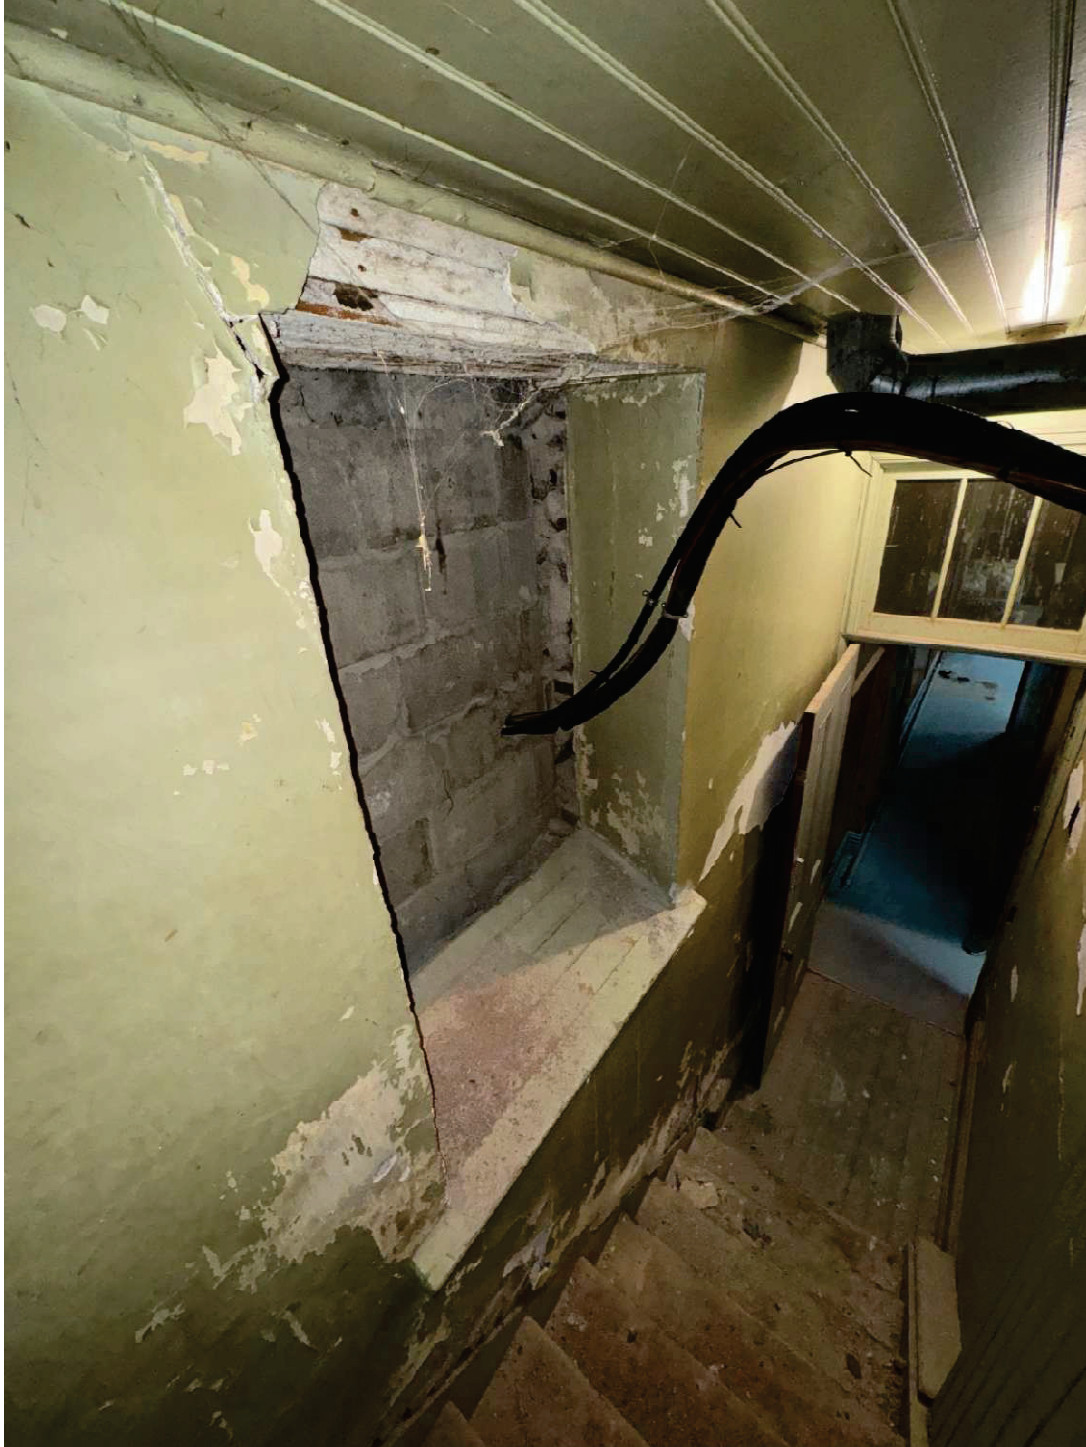
Photo #58

Closer view of the east foundation wall and a poorly closed window infilled with concrete blocks, looking south. The peeling paint and deteriorating surfaces in the area highlight the need for the cosmetic restoration.
