Township of Havelock-Belmont-Methuen Regular Council Meeting Agenda

Building Envelope Condition Assessment (BECA) Report

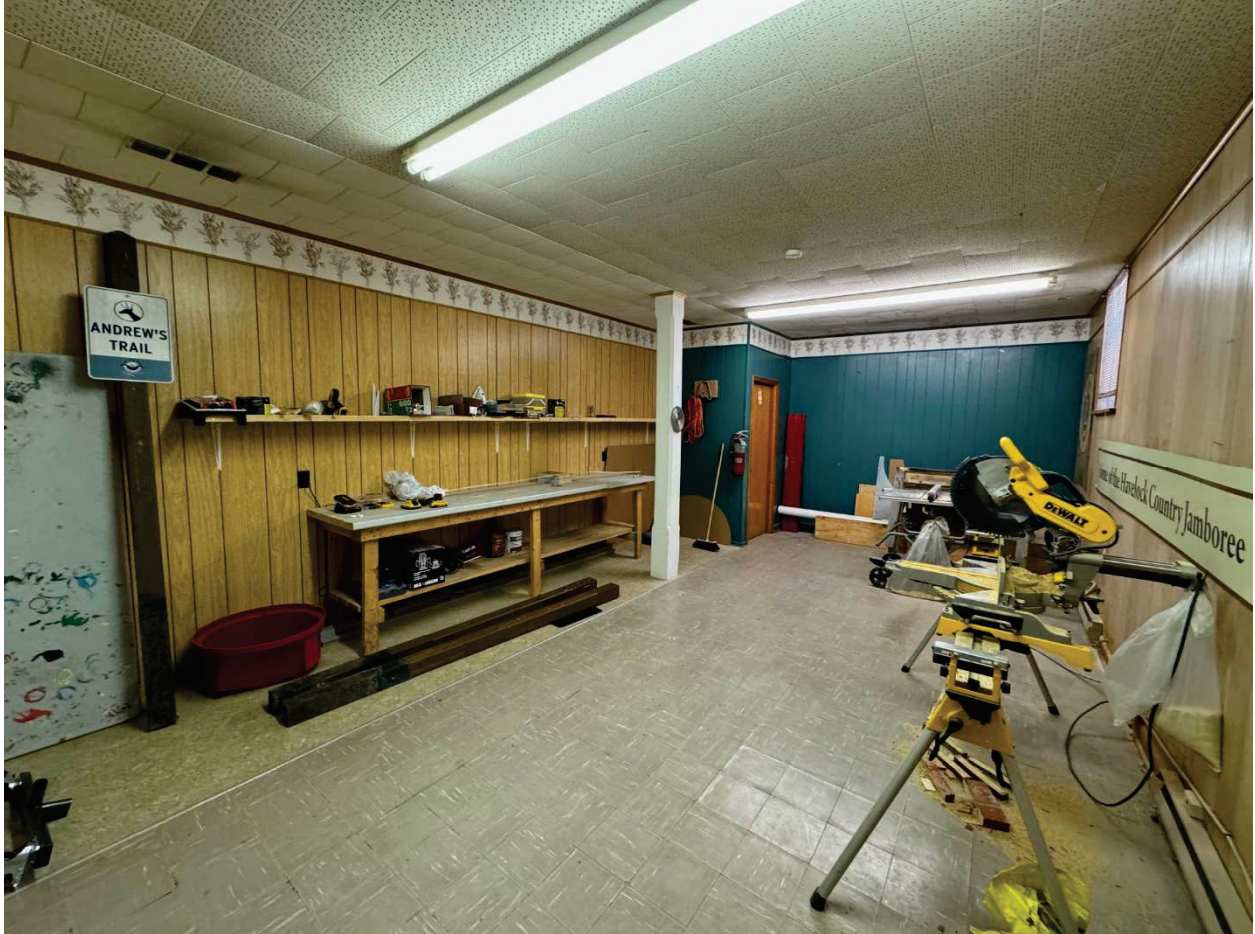
Photo #60

Entrance Corridor to the Carpentry Shop (Looking North): The grout finishing on the east foundation wall (right side of the photo) is peeling and spalling, as is the west interior foundation wall at the bottom.

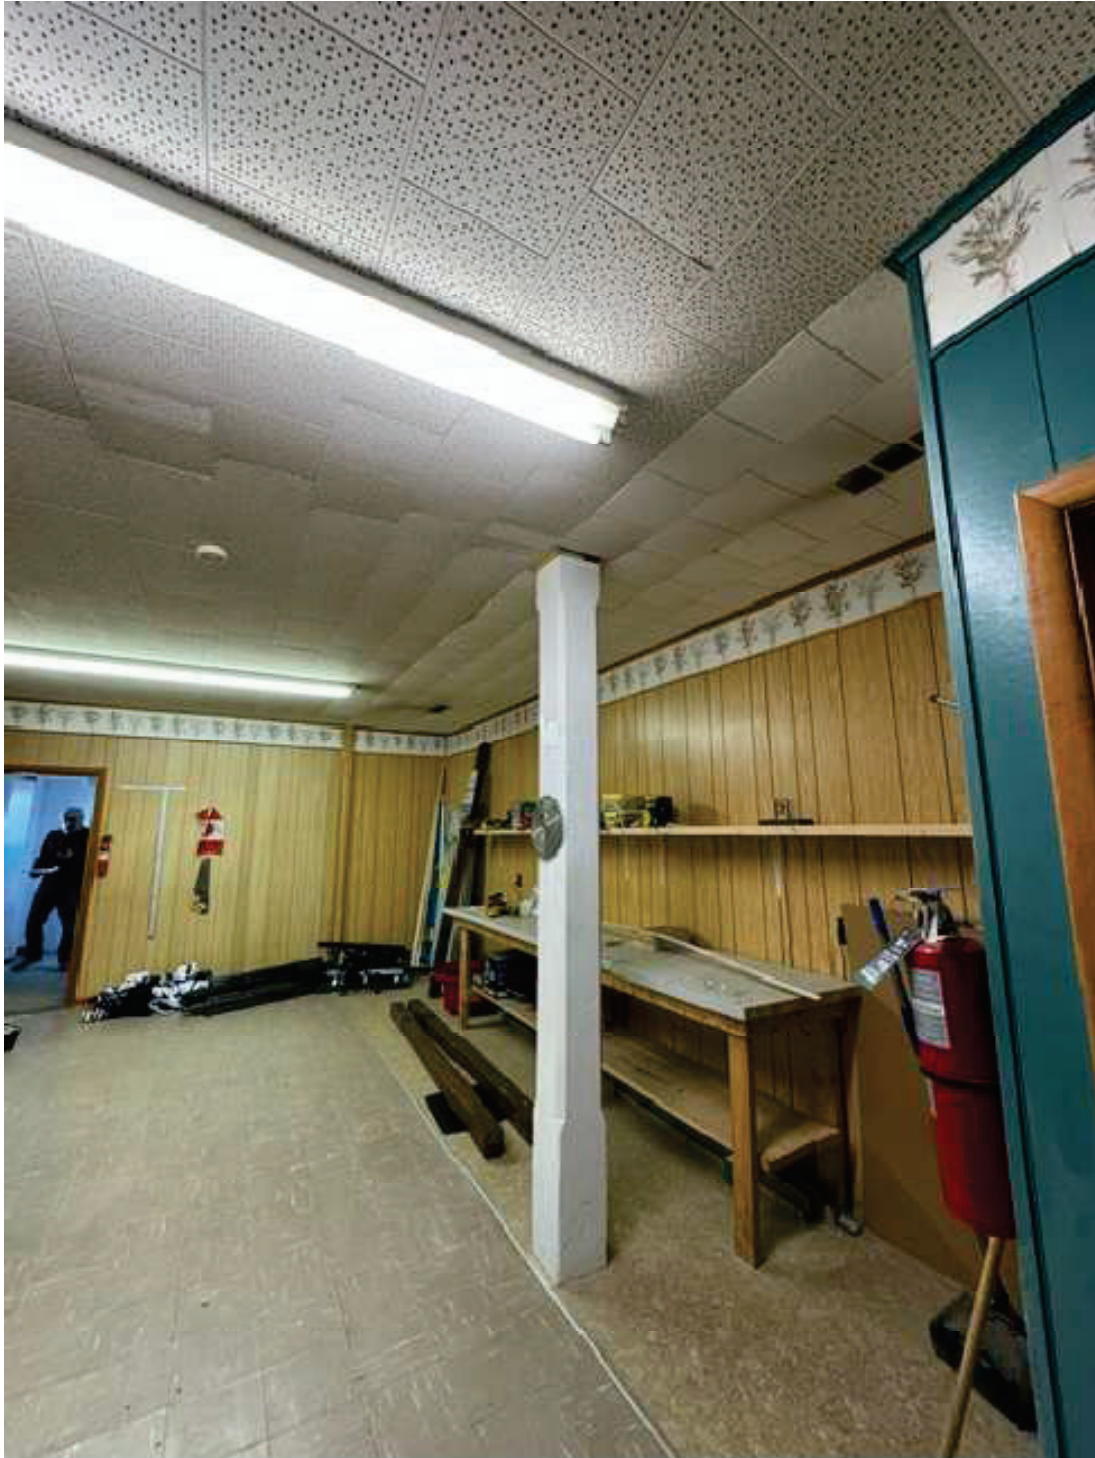
Photo #61

Photograph #61 shows the Carpentry Shop, Looking North from the Entrance Door

General view of the carpentry shop, looking north.
A structural wood column is visible in the space.

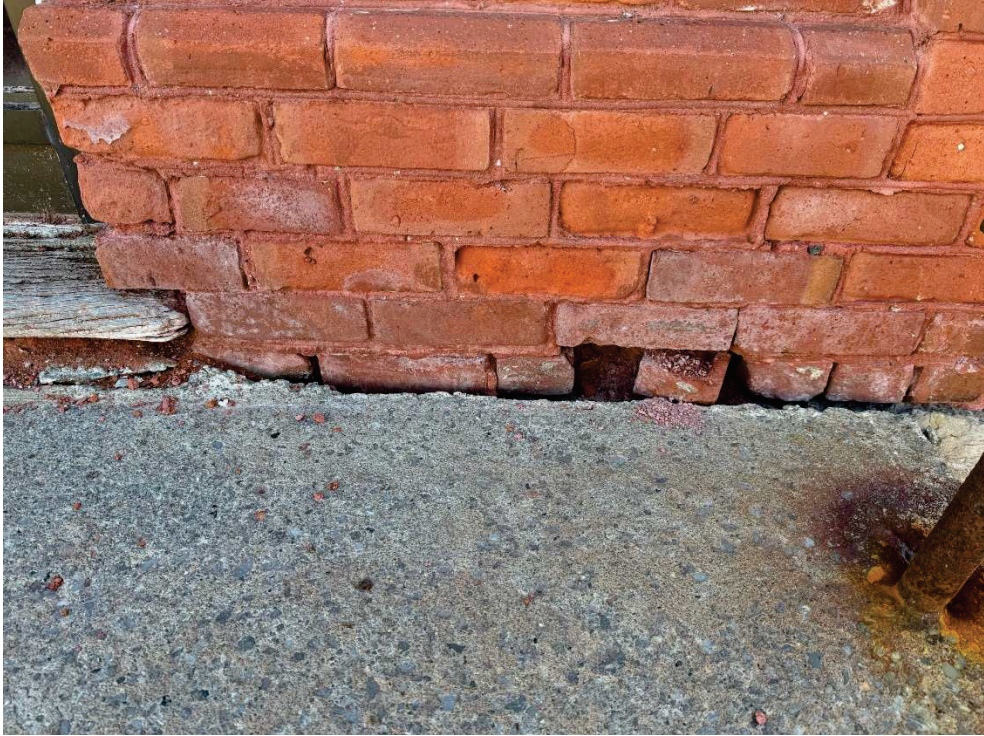
Photo #72
Entrance door threshold exhibits signs of settlement, with visible gaps and crumbling materials. The wooden threshold is weathered and misaligned.

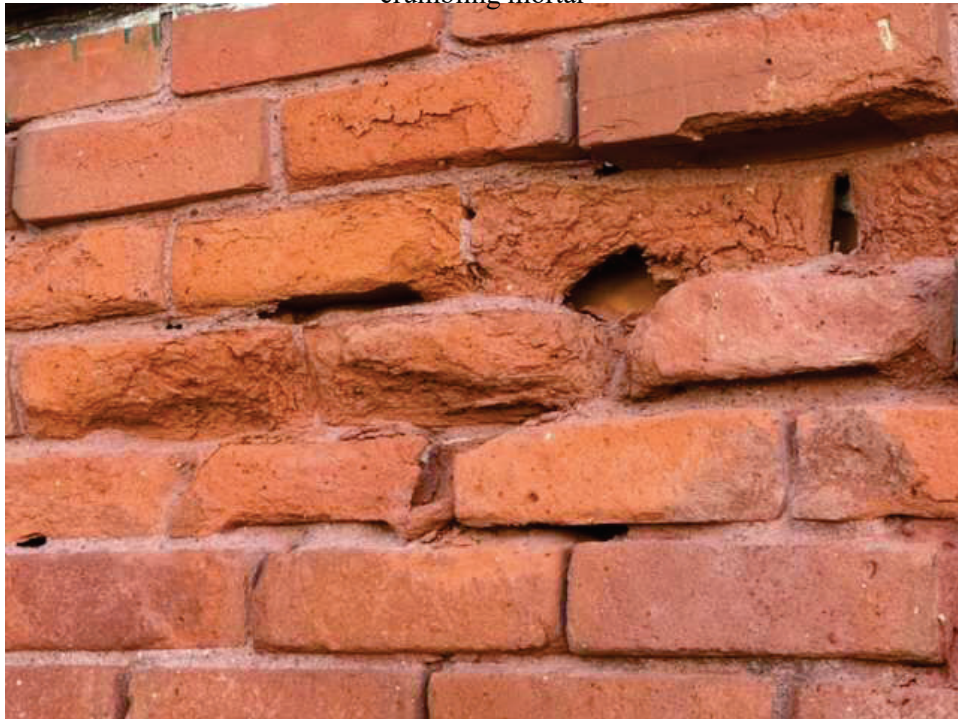
Photo #73

The brick wall near the stair entrance shows deterioration, with visible gaps, crumbling mortar

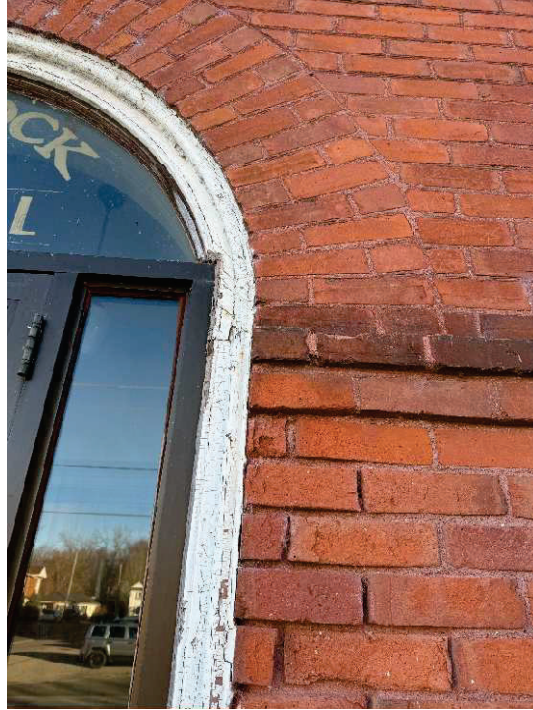
Photo #76

The north brick wall adjacent to the door entrance shows cracks, separation from the door frame, and gaps in the mortar joints. The paint on the frame is peeling.

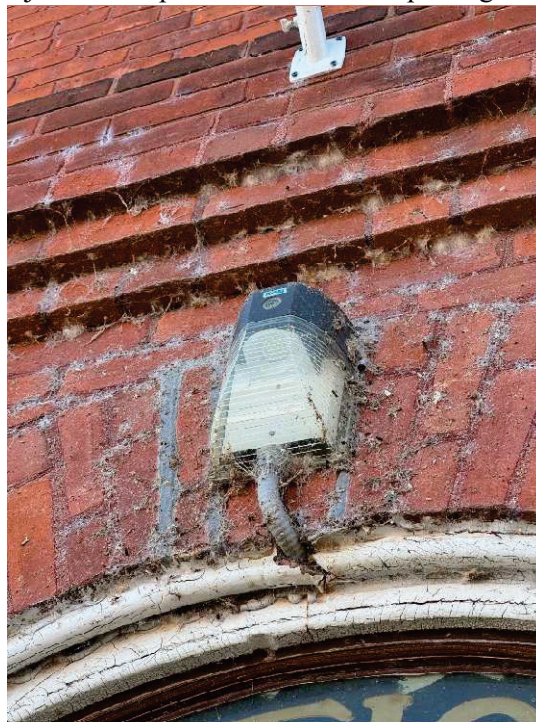
Photo #77

The north brick wall adjacent to the door entrance shows cracks, separation from the door frame, and gaps in the mortar joints. The paint on the frame is peeling.

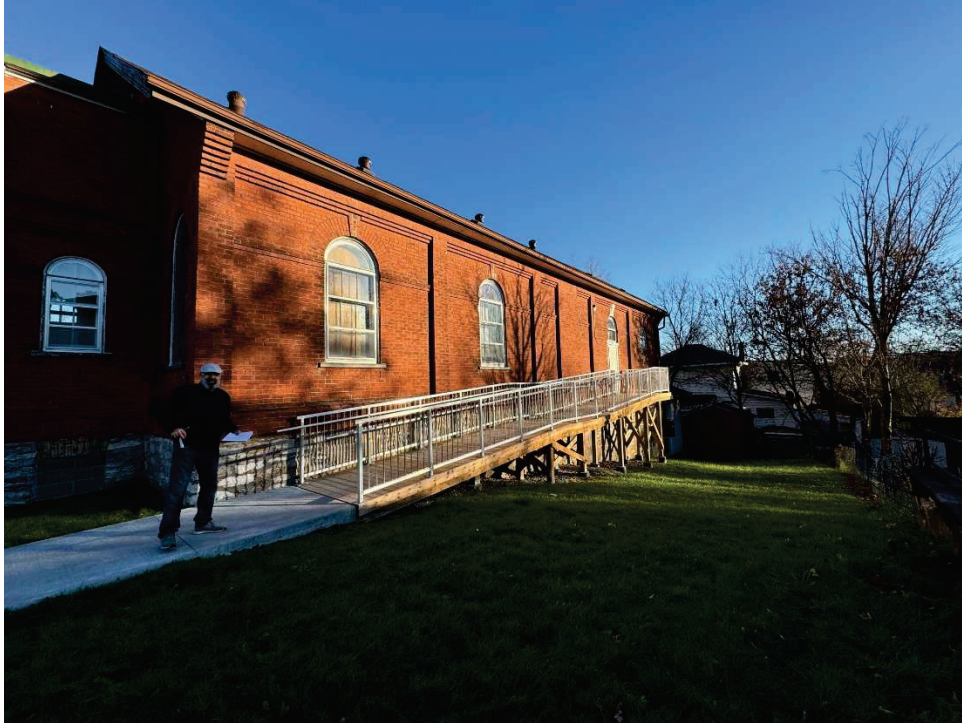
Photo #78

The brick above the entrance door around the light fixture shows signs of poor sealing and potential water infiltration. The buildup of dirt and cobwebs.

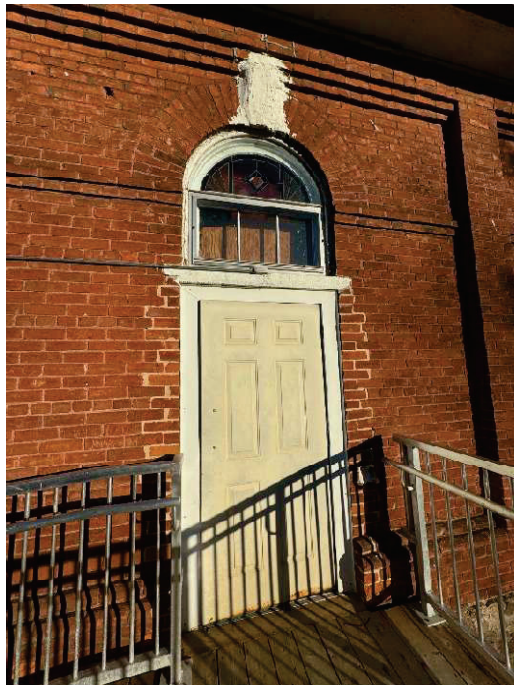
Photo #84

The window crown at the north elevation where cracks and gaps have been poorly sealed with sealant or mortar that does not match the original color. Discolored bricks are also visible in the brick masonry, indicating potential water damage or material degradation.

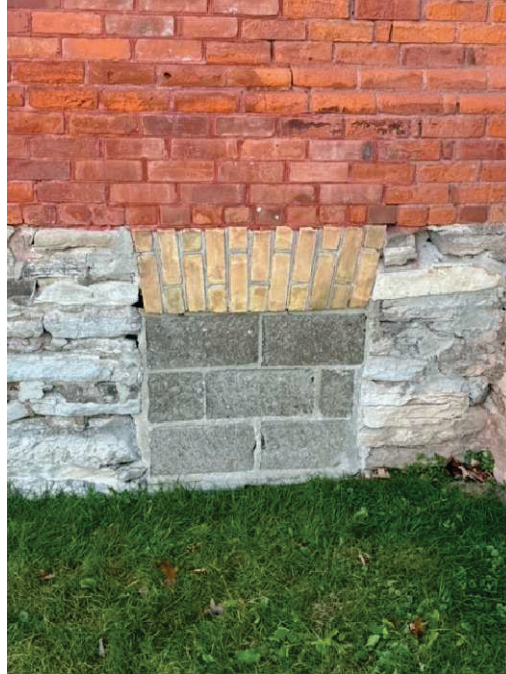
Photo #87

Photograph#87 shows one of the basement windows that all in this elevation have been infilled with concrete blocks. The foundation wall is constructed of masonry stone with cementitious grout. The infill is visually inconsistent with the surrounding stone and brickwork. Cracks are visible in the concrete block and joints. The grout joints in the stone foundation show signs of aging and wear, suggesting the need for maintenance and repair to preserve the integrity of the structure.

West Elevation Window Infilled with Concrete Blocks
The infill is visually inconsistent with the surrounding masonry. Cracks are visible in the concrete blocks and joints, while the grout joints in the stone foundation show signs of aging and wear.

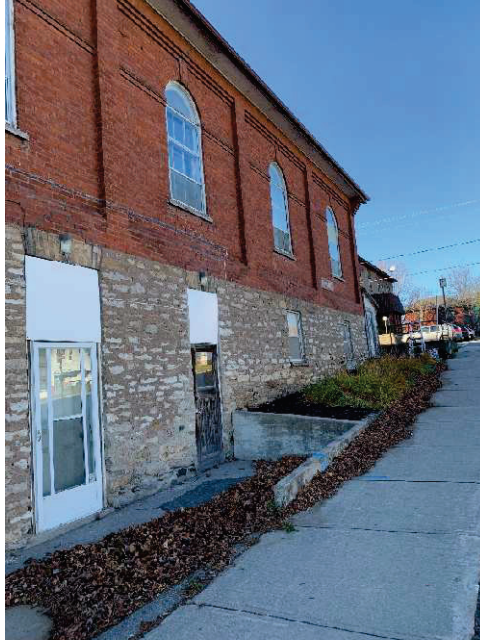
Photo #88

EAST: Photograph #88 shows the east elevation of the building, looking northwest. The elevation comprises brick masonry on the upper section and stone masonry on the lower section. The brickwork shows signs of cracking and inconsistent mortar repairs, indicating potential structural movement or aging materials. The wooden door at the basement level, likely for the carpentry shop, appears weathered and deteriorated. Additionally, the retaining concrete curbs and the slab-on-grade are in poor condition and require repairs to address water infiltration and prevent further deterioration.

Est elevation looking Northwest. The brickwork shows signs of cracking and inconsistent mortar repairs. The wooden door at the basement level (for the carpentry shop) appears weathered and deteriorated. The retaining concrete curbs and the slab-on-grade are in poor condition.

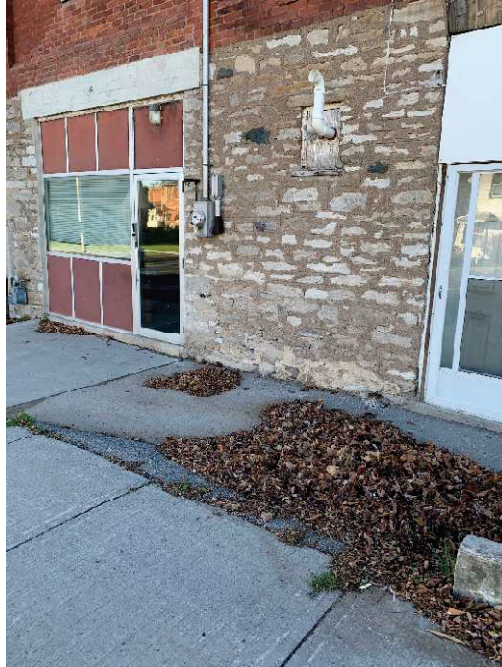
Photo #89

Photograph #89 shows the south section of the east elevation, looking southwest. The foundation wall at the police office has been partially demolished to accommodate a door with a metal façade. The original window

East Elevation South Section Renovations and Structural Concerns. Renovations, including a new door with a metal façade, reinforced concrete lintel, and an opening with PVC pipes. The concrete slab adjacent to the sidewalk shows mixed conditions, with one portion deteriorated due to water infiltration and poor drainage.

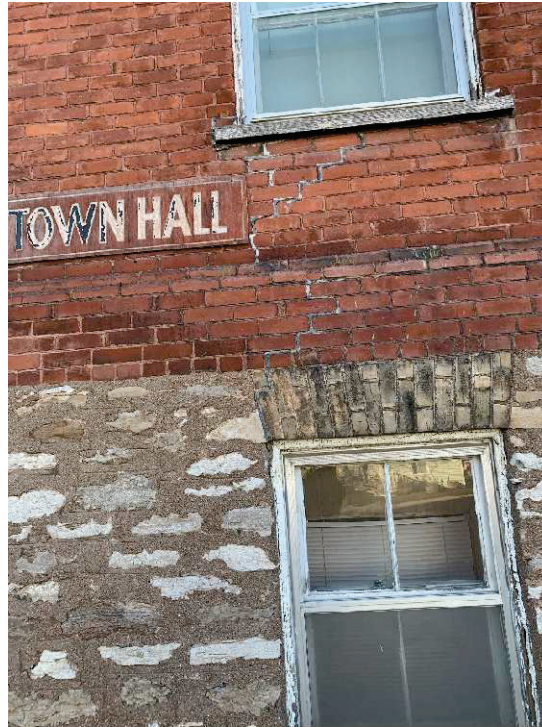
Photo #91

Cracks and settlement at east elevation windows are observed in the brick masonry located between the upper arched window and the basement-level window see photograph#90 & #91. The cracks suggest structural settlement or movement. The wooden sills of the upper windows show weathering.

Cracks at east elevation windows are observed in the brick masonry located between the upper arched window and the basement-level window. The wooden sills of the upper windows show weathering

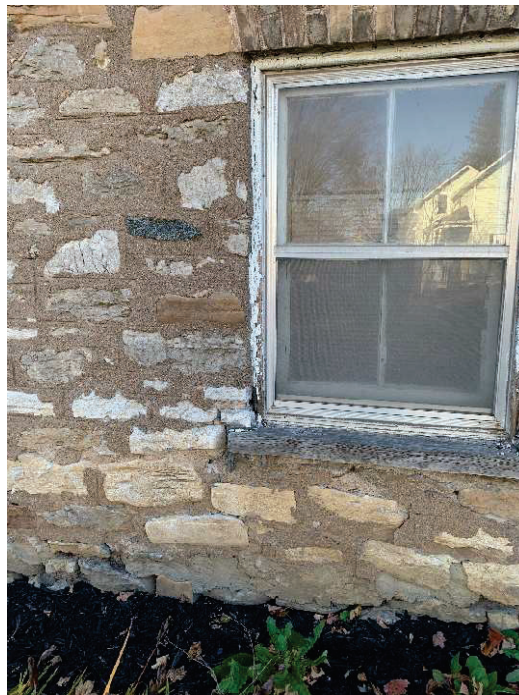
Photo #92

The photograph #92 shows the east elevation basement wall and window conditions. The basement wall is constructed of stone masonry with signs of weathering and inconsistent mortar repairs. The window frame exhibits peeling paint and deterioration, while the wooden sill is weathered and splitting. The overall condition suggests a need for maintenance to address aging materials and prevent further structural or water damage. The photograph #93 shows the east elevation at the carpentry shop entrance, with a weathered wooden door and a stone masonry wall exhibiting inconsistent mortar repairs. The adjacent concrete curb and the slab on grade are in poor condition, displaying cracks, uneven surfaces, and accumulated debris. Repairs are necessary to restore the functionality and aesthetic of the area.

East elevation and basement wall and window condition. Stone masonry with signs of weathering and inconsistent mortar repairs. Window frame exhibits peeling paint and deterioration, while the wooden sill is weathered and splitting. A need for maintenance.

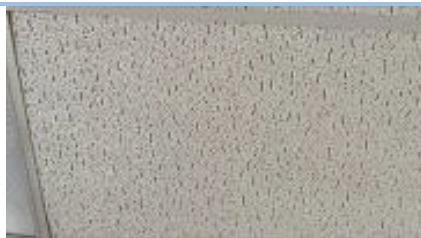
Material	Description	Sample #	Photo
Lay-in Acoustic Tile	White 2'x 5' acoustic tile from OPP office	4-1 to 4-3

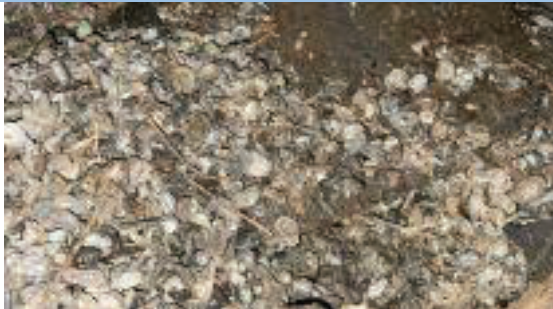
Material	Description	Sample #	Photo
Thermal Attic Insulation	Beige granular material.	1-1 to 1-3
